Troubleshooting Guide -

External condensation and related effects on sealed units

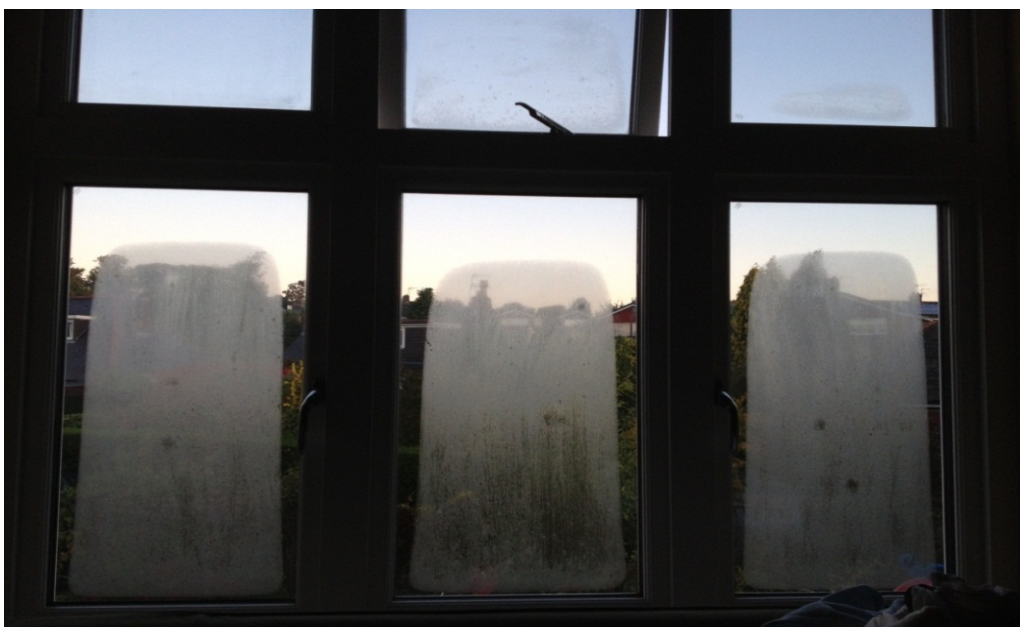
fig 1 –
External
condensation
, border
effect and
pad residue
on A Rated
EnergiMAX™
DGU
installation

Sealed units are at their most efficient at the centre, where the cavity, coatings and inert gas filling best do their job. Towards the very edges, the spacer bar and the window frame itself can themselves conduct a little more heat than at the centre. We offset this by the use of warm edge spacer bars and thermal frame inserts, but this slight extra transmission of heat as well as that radiated from the frame is sufficient to create a warmer edge and thus a condensation free border at edge of the glass.

These aren't faults, neither are they permanent, they are just surface effects are from the various bits of equipment that have come into contact with the glass both here and at the glass manufacturing plant itself. Microscopic layers of film residue from cork pads, suction cups etc, and even hand or finger prints will show up when condensation forms on the glass. They are external effects which will disappear over time and has no effect on the performance of the unit.
