A Clear Guide to CONDENSATION

As we move into the colder months of the year, condensation can start forming on windows. This guide explains what it means to you and your customers

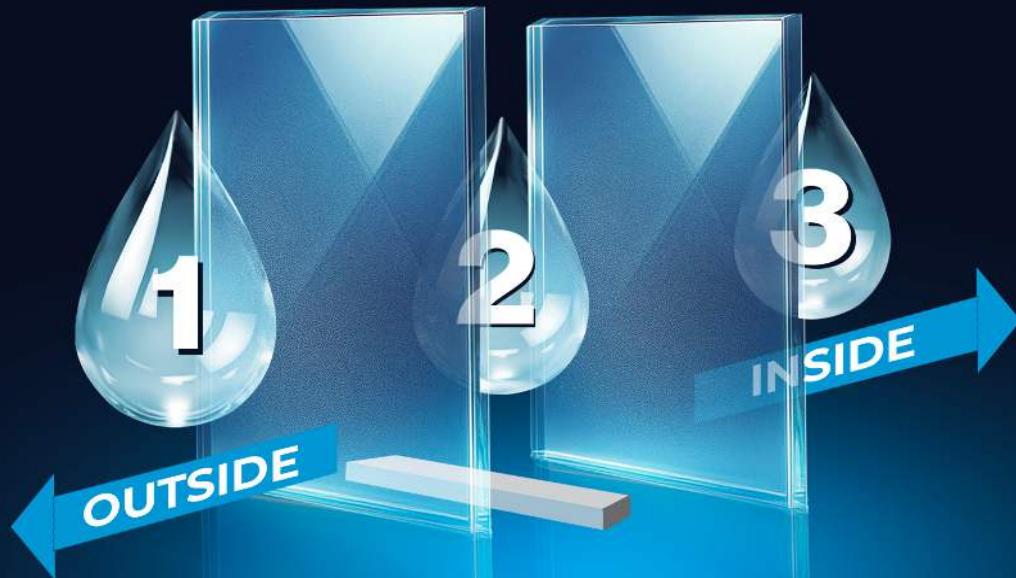
1 Is it on the outside?

Condensation forming on the outdoor face is a positive indication that heat is being retained inside the home and the glass is thermally efficient. This is a natural phenomenon and not an IGU fault.

2 Is it inside the cavity?

Condensation inside the cavity indicates the IGU seal has broken down, this is a failure of the IGU.

3 Is it on the room side?

This is due to warm, moist air being trapped in the building. This indicates a problem with building itself suggesting that increased air ventilation is required. The condensation on the glass is a symptom and not a sign of a faulty IGU.
